# Manhole Inspection Summary

## Manhole # S37WW\_030MH

Insp Date: **1/4/07 12:01 PM**

**Location** Address: **3010 GREENMOUNT AVE**

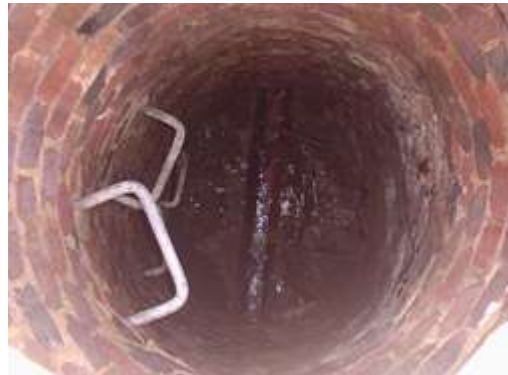
Top View

Corbel and Barrel infiltration. Evidence of surcharge - Bench debris.

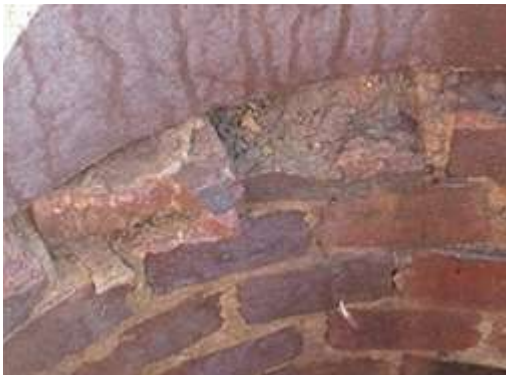
Defect

Condition: ☐ Sound ☐ Cracked ☐ Root Intrusion ☐ Loose Brick ☒ **Deteriorated**

Infiltration: ☐ None ☒ **Joint** ☐ Cracks ☐ Mortar ☐ Roots ☒ **Wall**

Adjustment deterioration and infiltration.

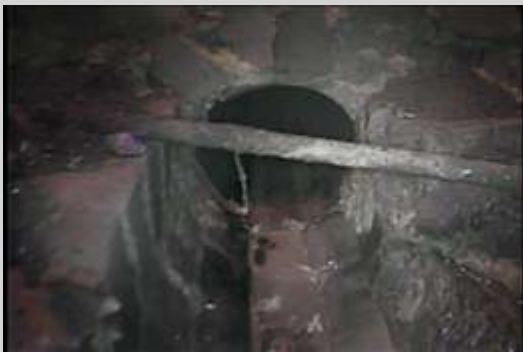
### 8 in. Circular Gravity Sewer Pipe Out @ 12 O'Clock

Invert Depth: **9.31** (ft.) Flow Characteristics: **Slow**

Infiltration: **None** Pipe Seal Cond: **Unknown**

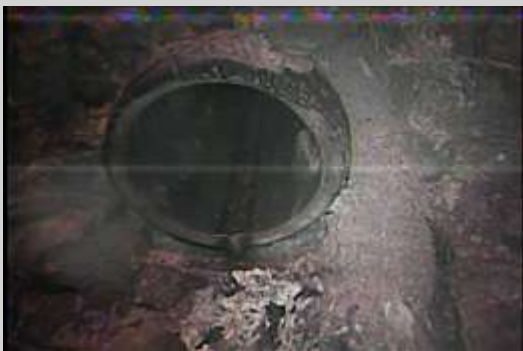
### 8 in. Circular Gravity Sewer Pipe In @ 3 O'Clock

Invert Depth: **8.70** (ft.) Flow Characteristics: **Slow**

Infiltration: **None** Pipe Seal Cond: **Unknown**

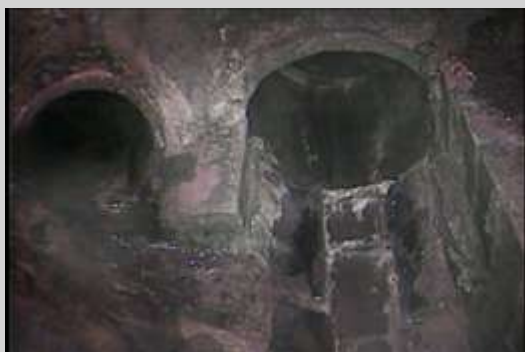
Pipe In @ 6 O'Clock

Invert Depth: **9.01** (ft.) Flow Characteristics: **Slow**

Infiltration: **Evidence**
